United States  
Department of  
Agriculture

Forest Service

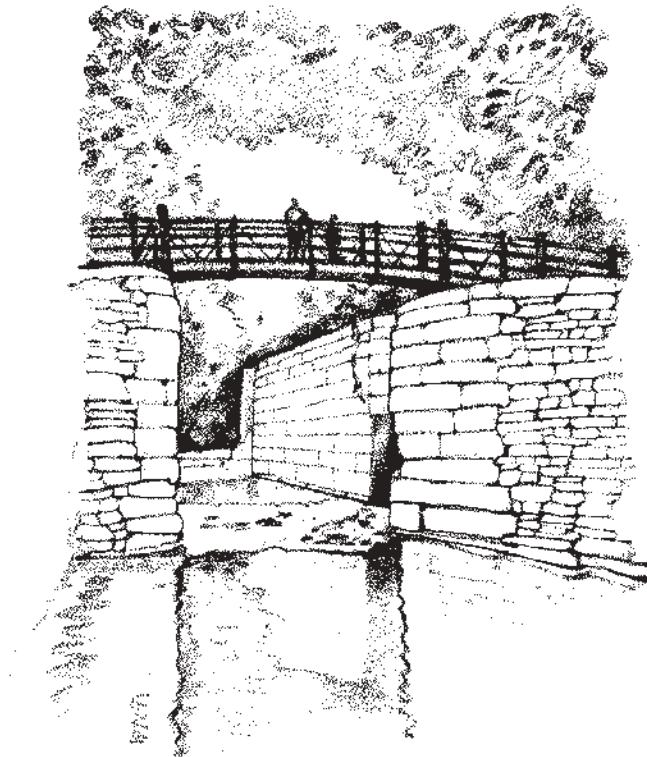
Potholes or cracks may form when asphalt pavement fails on timber bridge decks. Asphalt pavement may dissolve and decompose, or the asphalt and preservative chemicals or solvents may bleed to the pavement surface and to the underside of the bridge. When asphalt pavement contains too much asphalt, the

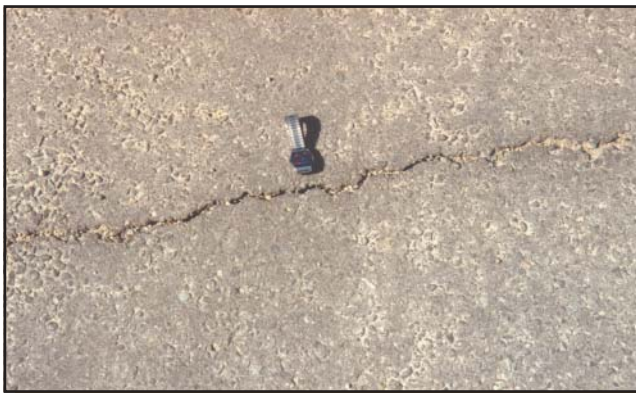
Figure 2—Cracking over panel joints on the Watchtower Creek Bridge at the Bitterroot National Forest, MT, in 1989.

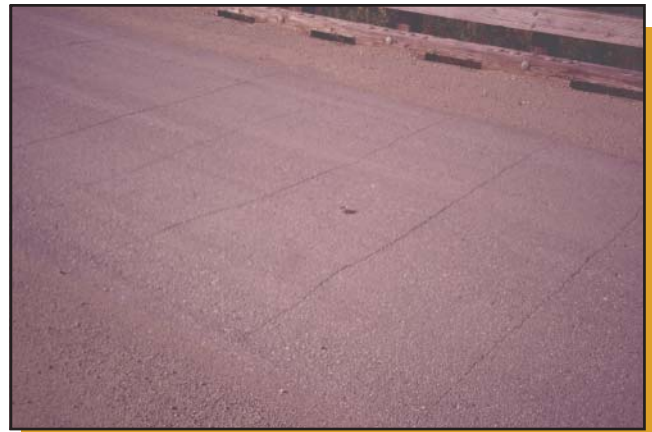
Figure 3—Cracking over panel joints on the Watchtower Creek Bridge at the Bitterroot National Forest, MT, in 2000.

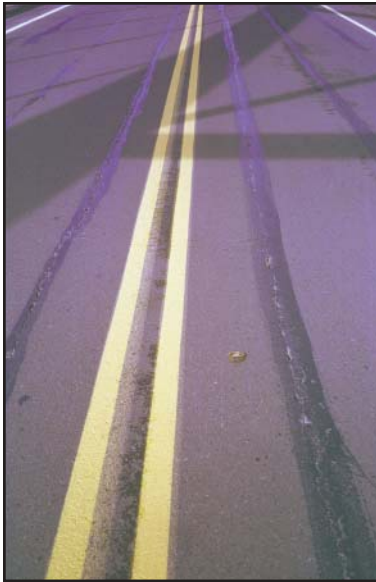
Figure 4—Longitudinal cracks over the deck panel joint on the Satsop River Bridge near Shelton, WA.

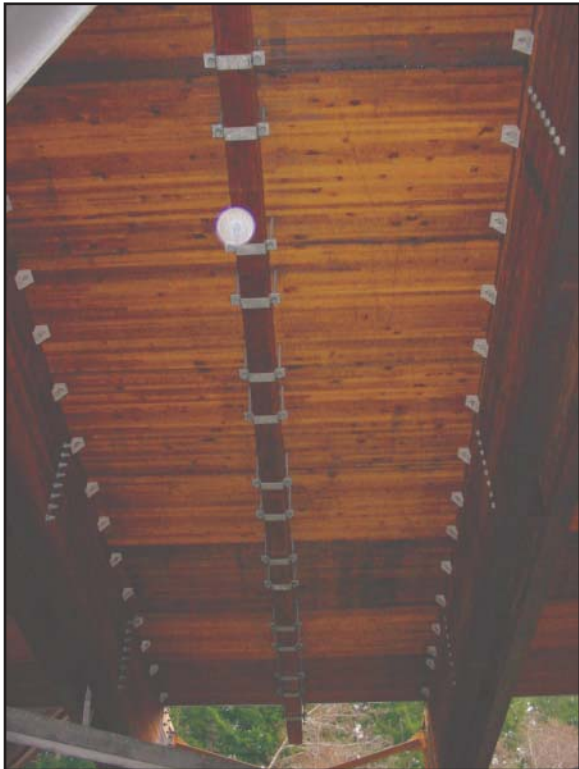
Figure 5—Distribution beam installed under the Satsop River Bridge.

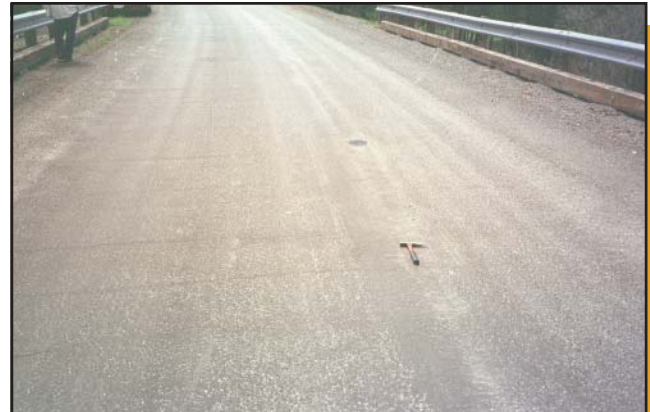
Figure 6—Bridge across Wolf Creek near Libby, MT, showing minimal cracking.

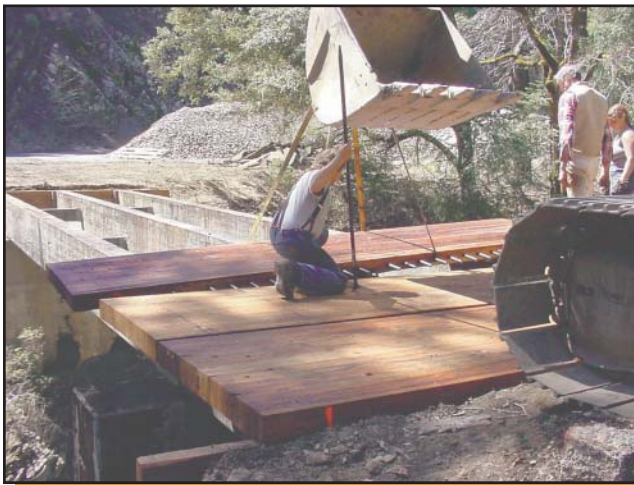
Figure 7—Dowel-interconnected, transverse glued-laminated deck panels on the Mill Creek Bridge near Medford, OR.

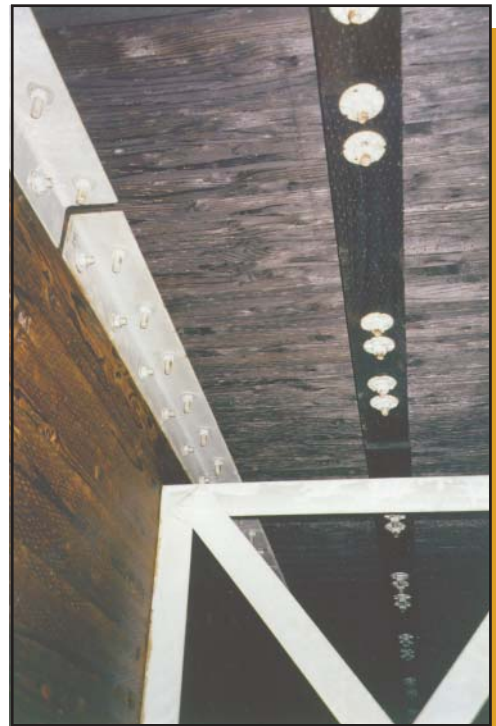
Figure 8—Deck stiffener beams installed under transverse glued-laminated deck panels on the Lighthouse Bridge near Port Angeles, WA.

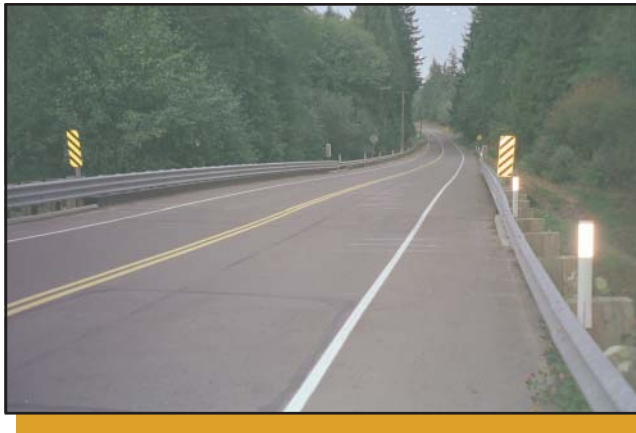
Figure 10—Crack-free deck on the Lighthouse Bridge near Port Angeles, WA.

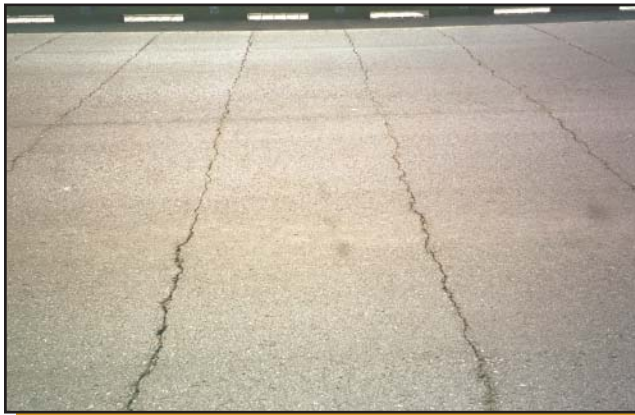
Figure 11—The pavement cracked about 1 year after construction of the Standish Avenue Bridge in Petoskey, MI.

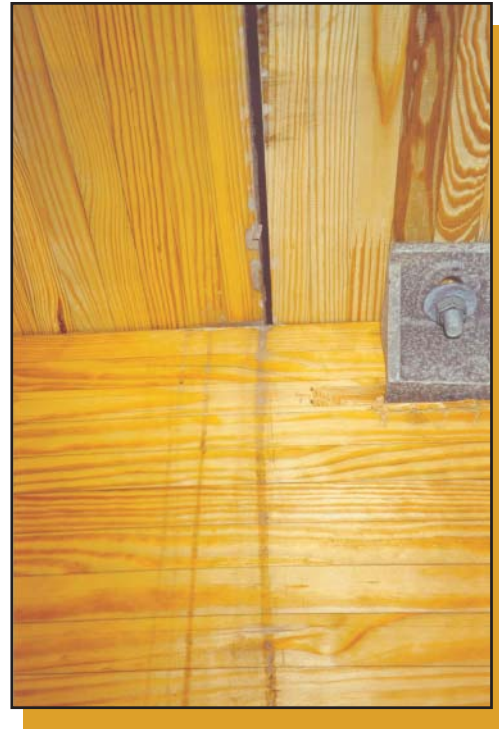
Figure 12—Shrinkage of deck panels contributed to pavement cracking on the Standish Avenue Bridge.

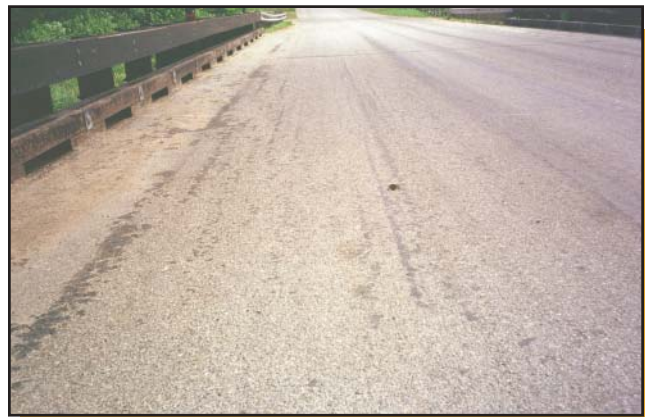
Figure 15—The Cameron Bridge in Crawford County, MI, had asphalt bleeding over glued-laminated webs.

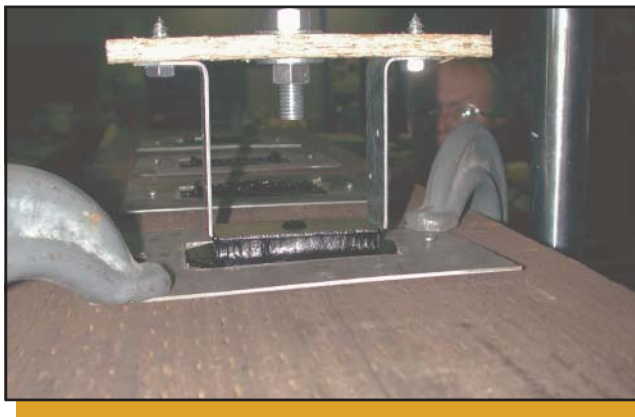
Figure 18—Tension being applied to the pullout brackets.

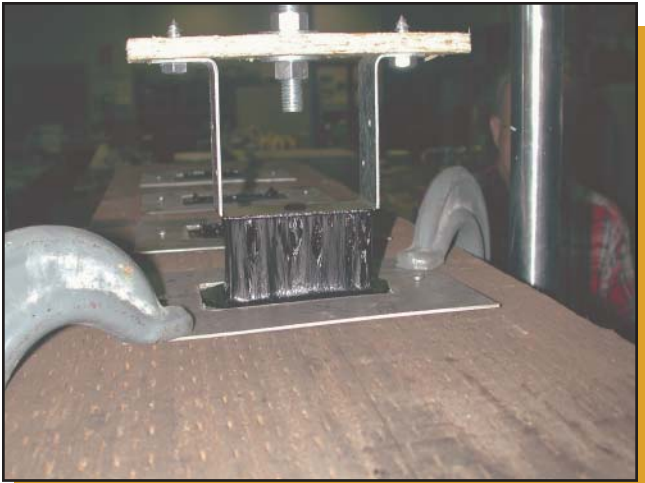
Figure 19—Asphalt adhesion test after the asphalt failed when it had elongated.

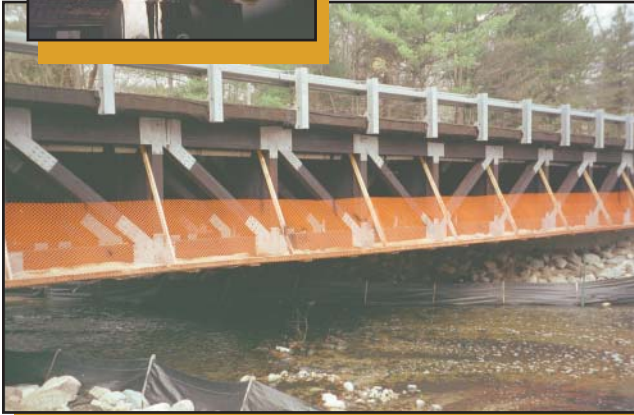
Figure 20b—A collection system catches the creosote and rubberized asphalt dripping from the underside of the bridge.

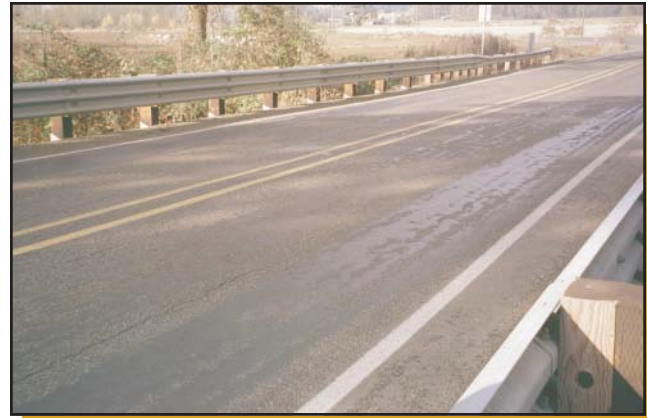
Figure 21—Alternating longitudinal deck panels treated with penta and copper naphthenate on a bridge in Washington County, OR.
