Jackson Covered Bridge Rehabilitation

The Jackson Covered Bridge over Sugar Creek is being rehabilitated. Work on the \$1.4 million Federal Aid project is nearly complete. The project included the removal of the roof and siding. The bridge frame was moved off of the abutments for the rehabilitation. The bridge was removed from the abutments in February 2007. The bridge was put back on the abutments in August 2007. Additional information can be found at the following website:

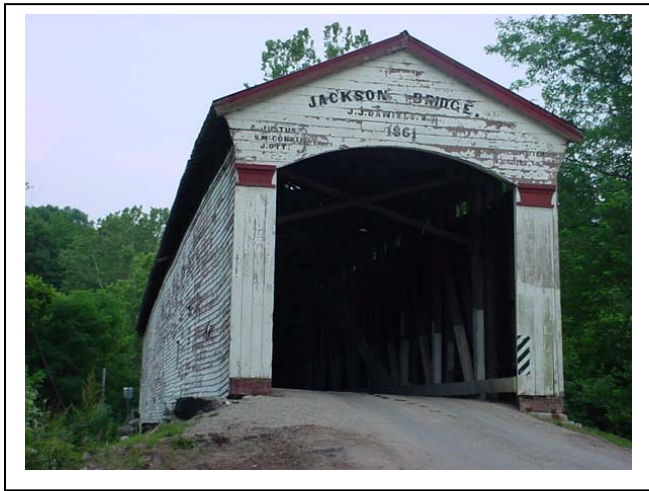
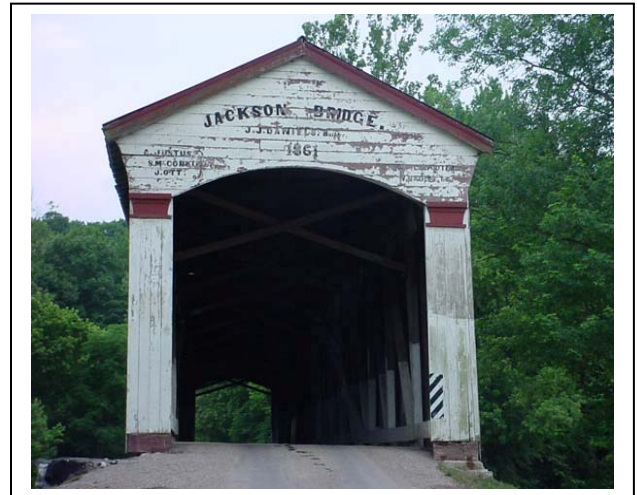
These pictures were taken in June 2006 and show the condition of the bridge before the rehabilitation began

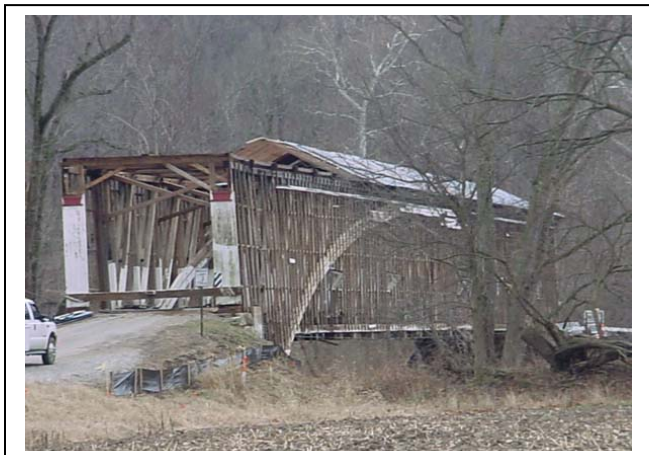
December 26th The siding has been removed from the Jackson Covered Bridge and work has started on the removal of the roof.

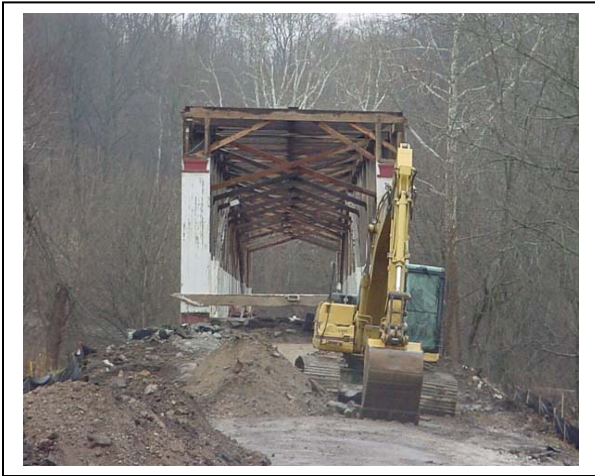
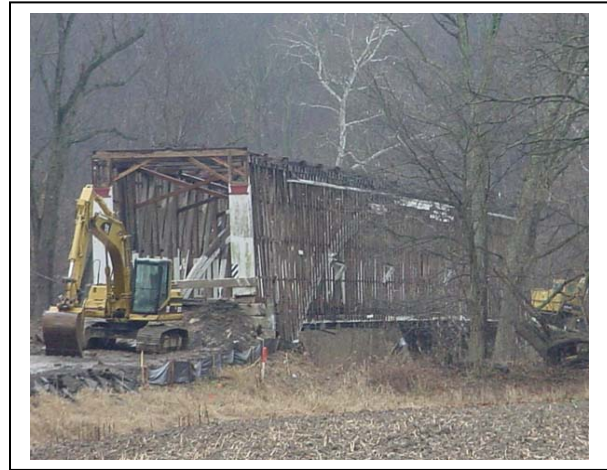
January 4th The roof has been removed from the Jackson bridge. Equipment has been brought in to work on the approaches in preparation for moving the bridge.

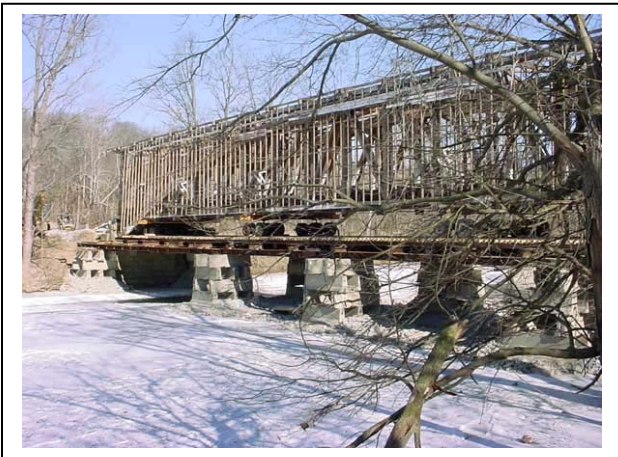
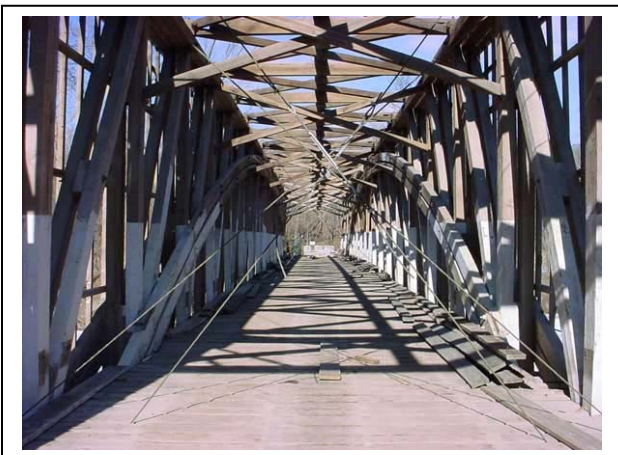
February 2007

February 3rd The temporary bridge is complete and the dollies have been placed under the bridge. The dollies have built in jacks which will be used to lift the bridge. The bridge was to be moved on Tuesday, February 6th, however, the temperature is below 10 degrees. The move has now been postponed until next week when the temperature should be warmer. These pictures were taken from the south side of the bridge.

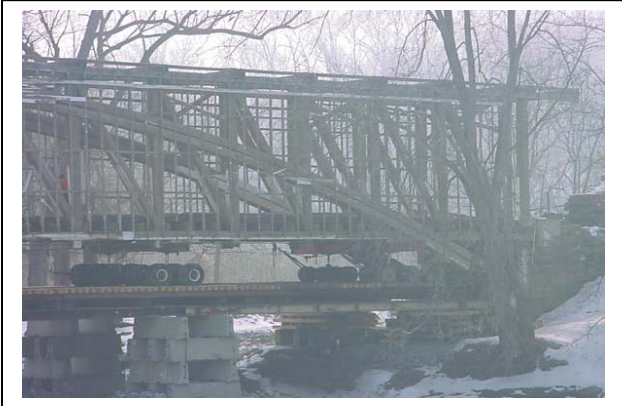
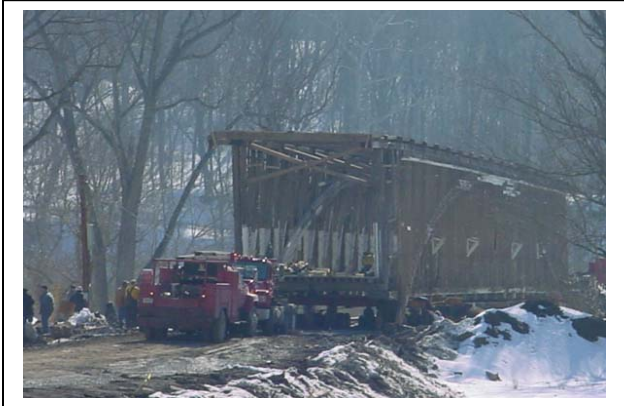
February 21st The Jackson Bridge was moved off of the abutments and placed on the road bed. The bridge move took approximately 3 hours to be moved. The bridge was pulled using a winch attached to a truck.

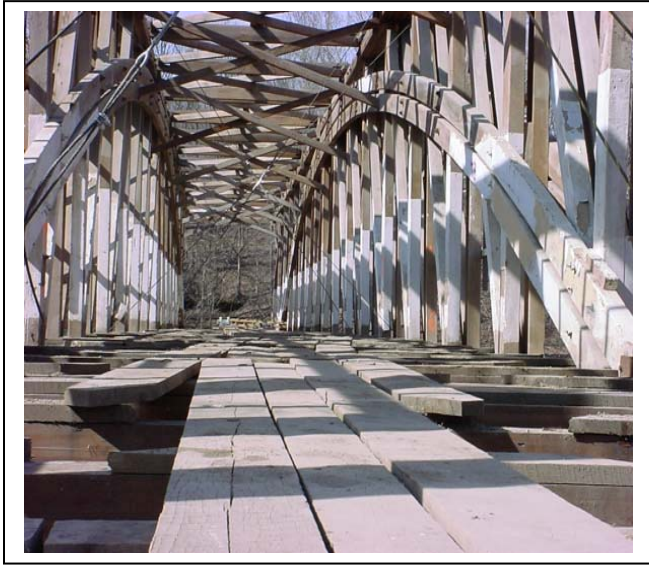
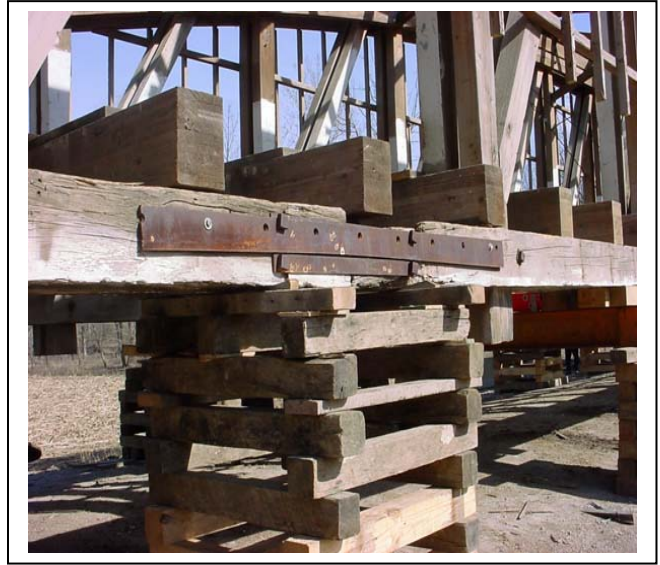
March 11th The Jackson Bridge has been braced and the reconstruction has started. Some more boards have been removed from the bridge.

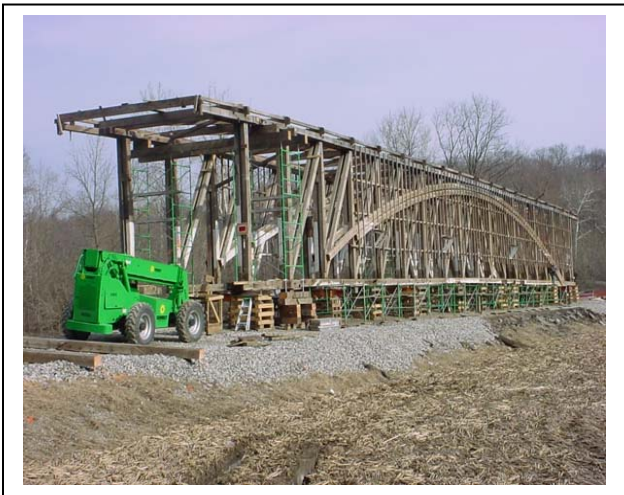
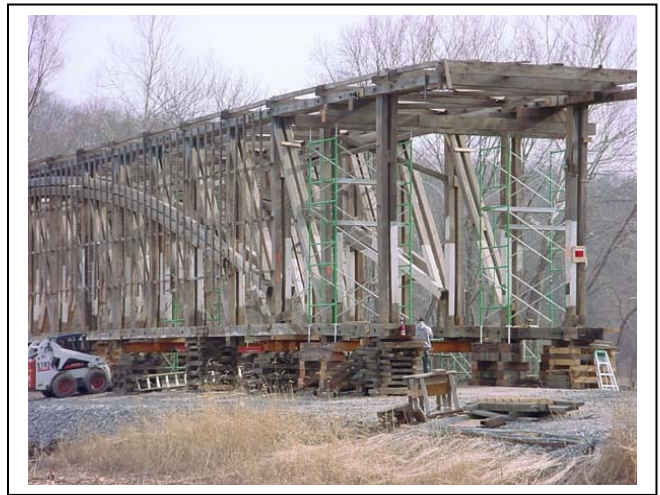
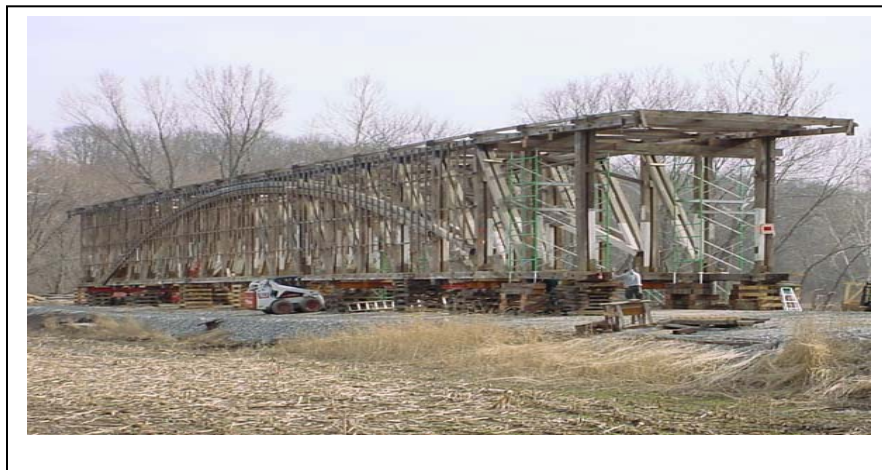
March 20th Scaffolding has been erected to support the Jackson Bridge as the original timbers are being removed. The floor has been removed and the arches are being disassembled.

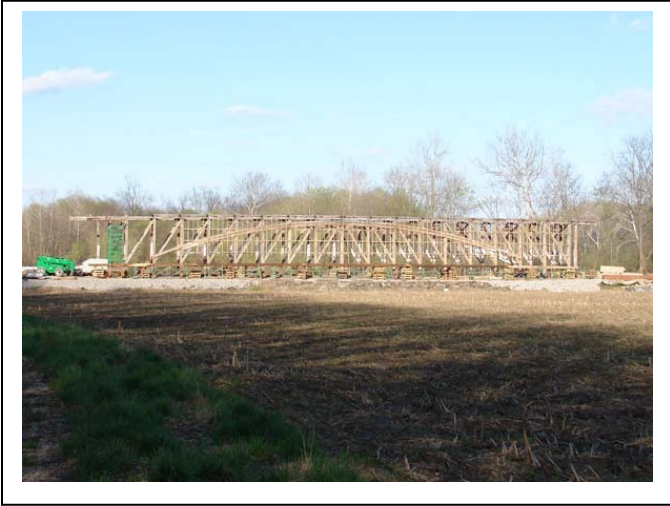
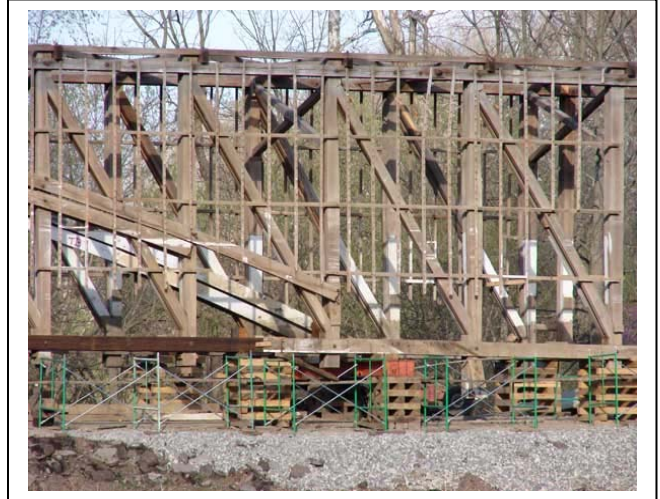
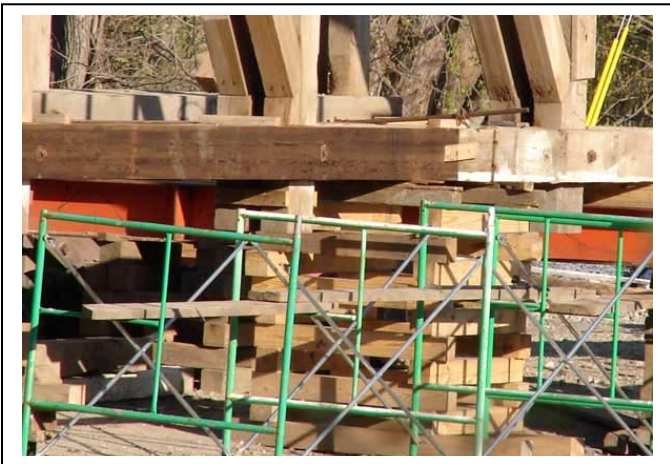
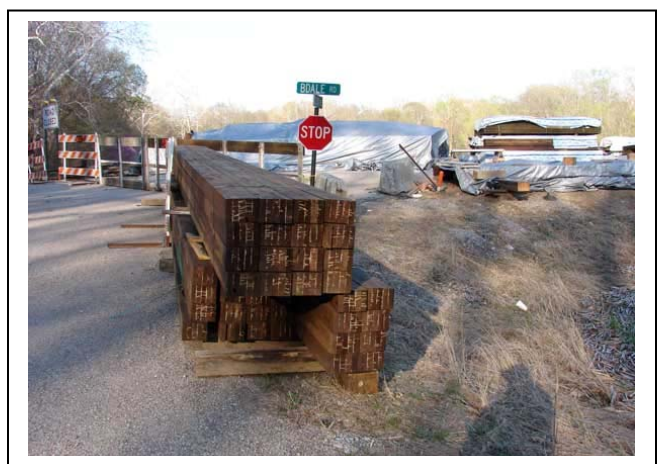
April 5th The contractors have removed the bowing of the bridge. (The bridge was twisted and one of the engineers speculated that it had been hit by a tornado.) The lower cords of the west side of the bridge are currently being replaced. The workers have also removed most of the cribbing from the creek, the cribbing was creating a dam and causing bank erosion. New treated laminated timbers are being installed on the bridge. Piles of the new timbers have been delivered for the bridge.

April 15th The siding supports are being removed so the arches can be repaired. The workers have also removed all of the cribbing from Sugar Creek.

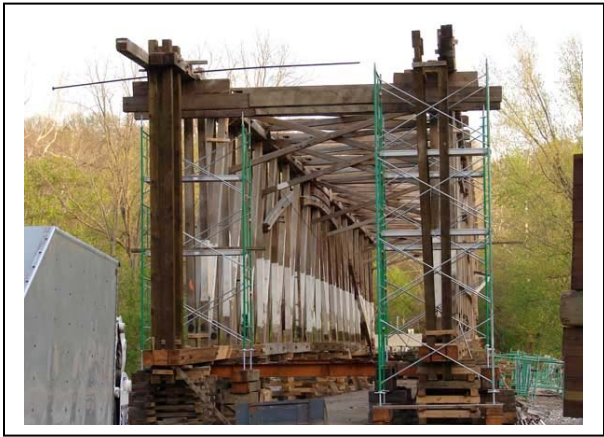
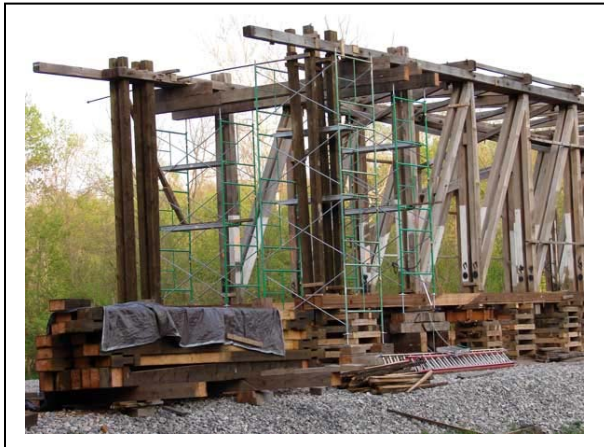
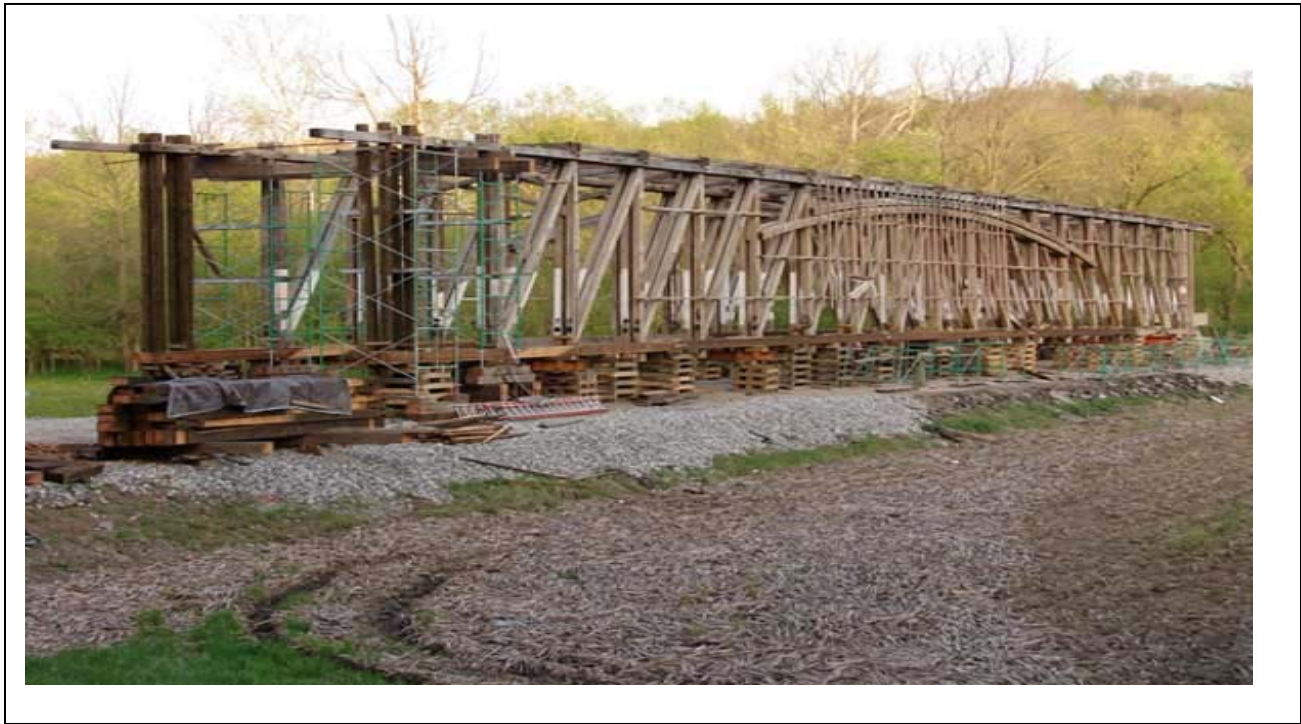
April 28th The lower cords on the east side of the bridge are being replaced. The north end of the bridge is also being reconstructed.

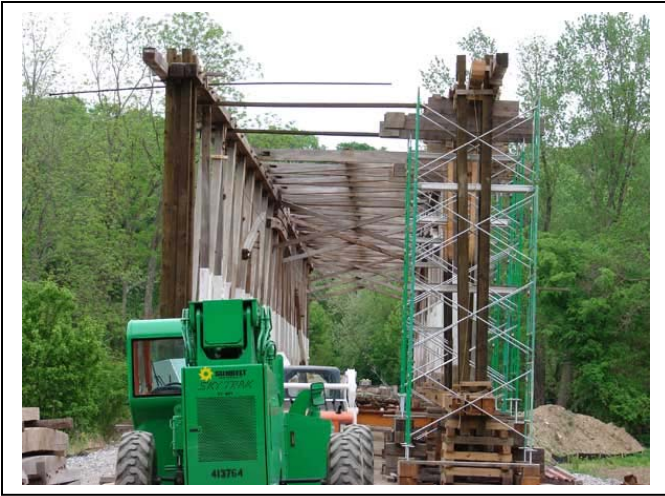
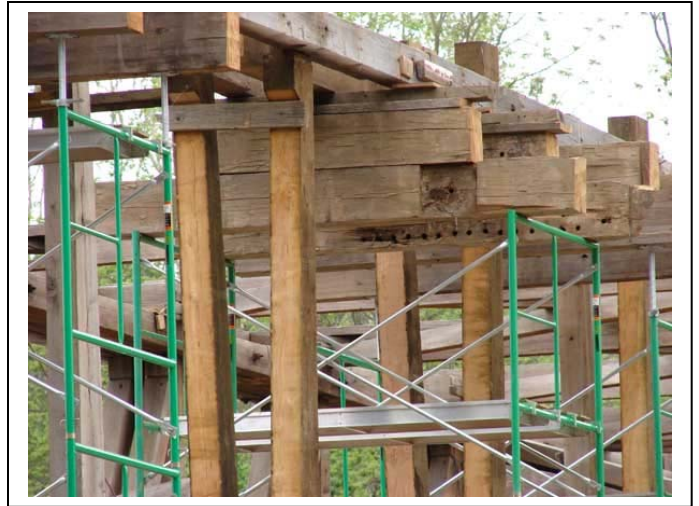
The damaged wood of the arches have been removed and new lower cords are being installed. Work is being done on the upright posts.

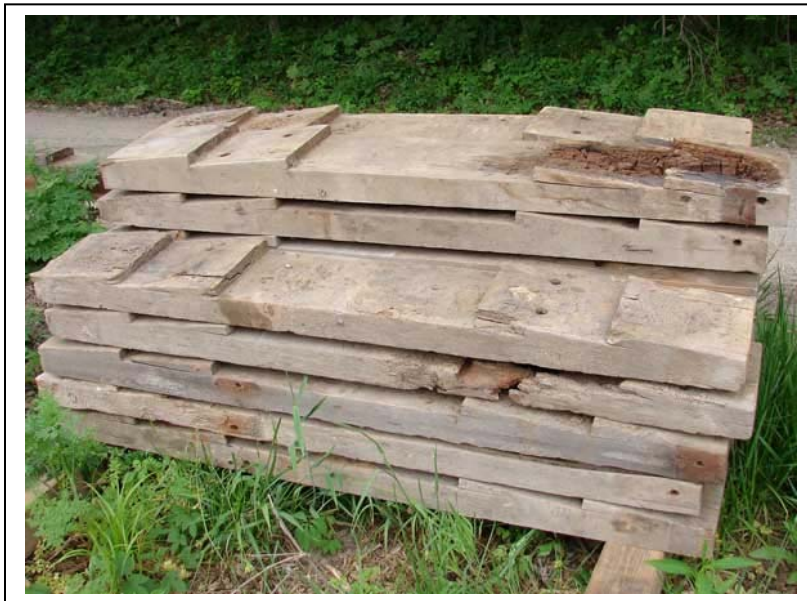
May 10th Here are some of the old joint pieces that were removed from the bridge

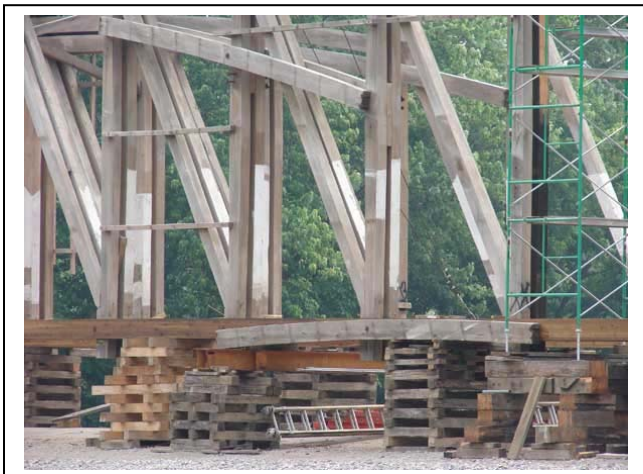
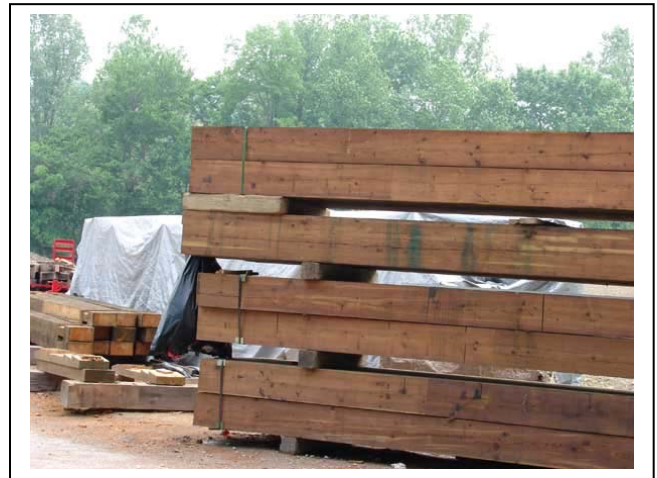
May 25th Piles of new lumber are ready to be installed on the bridge

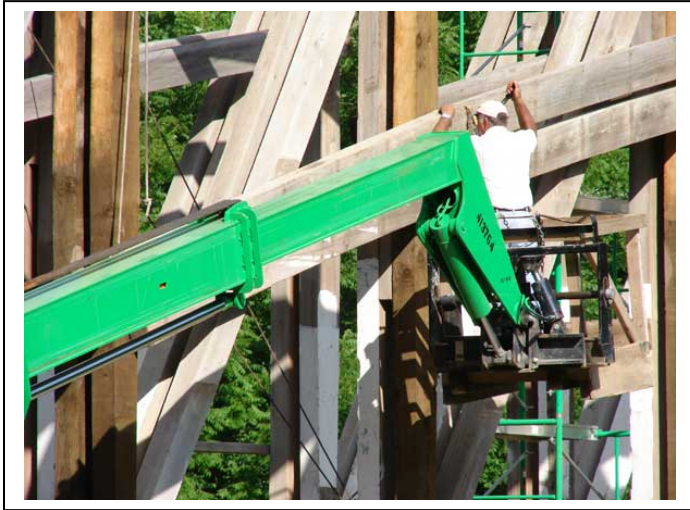
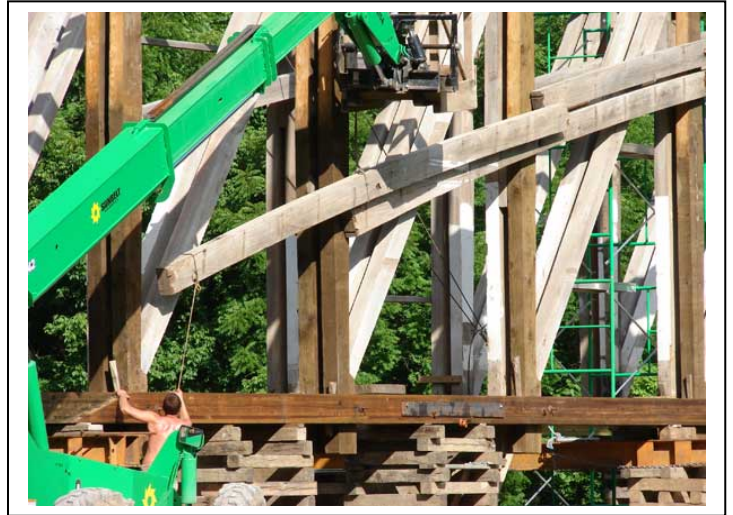
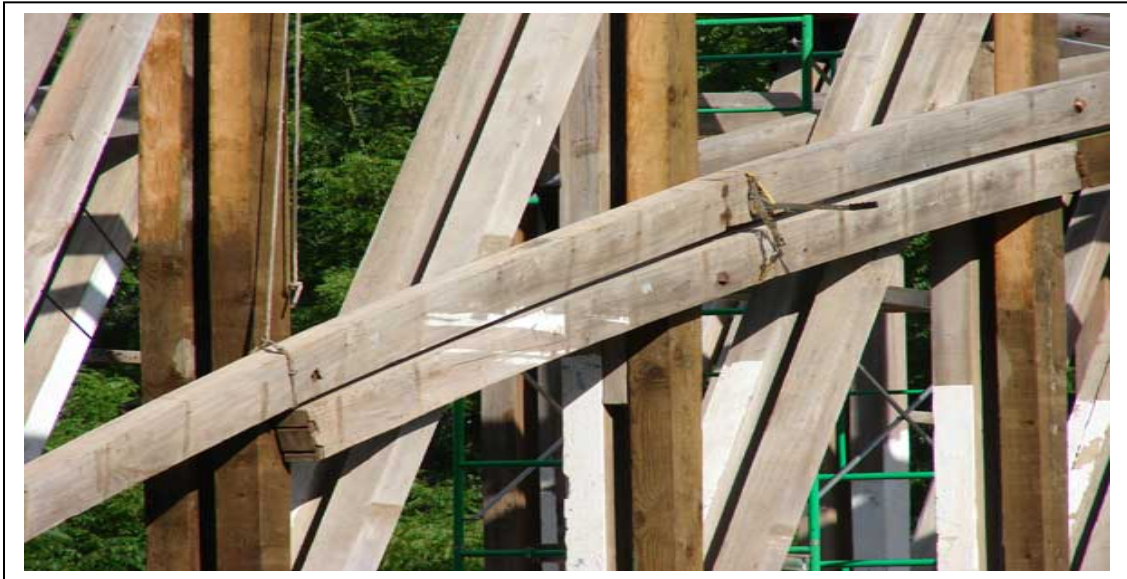
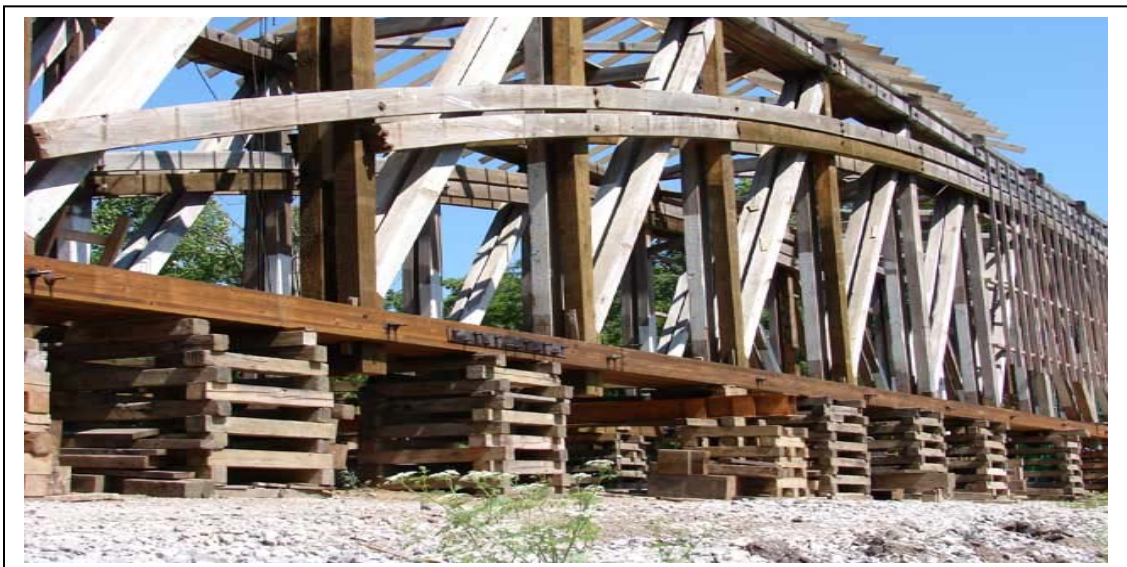
Here are a series of pictures taken while the workers were installing a section of the west arch.

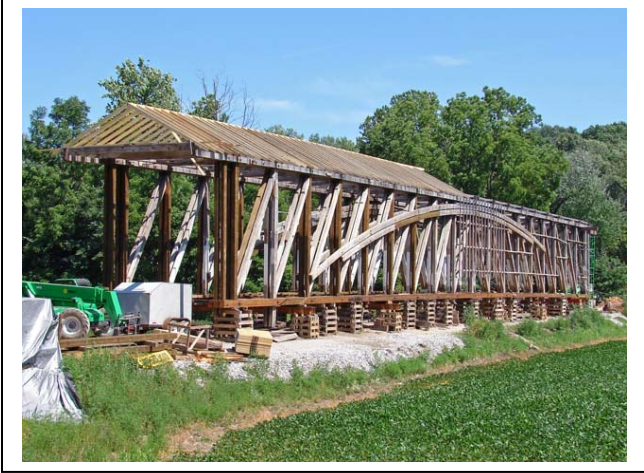
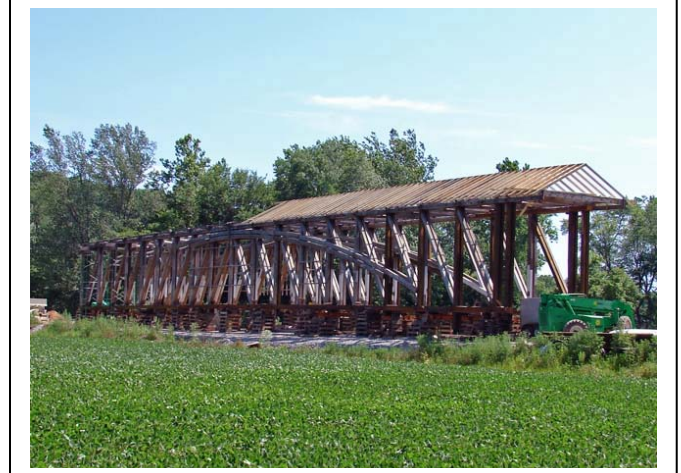
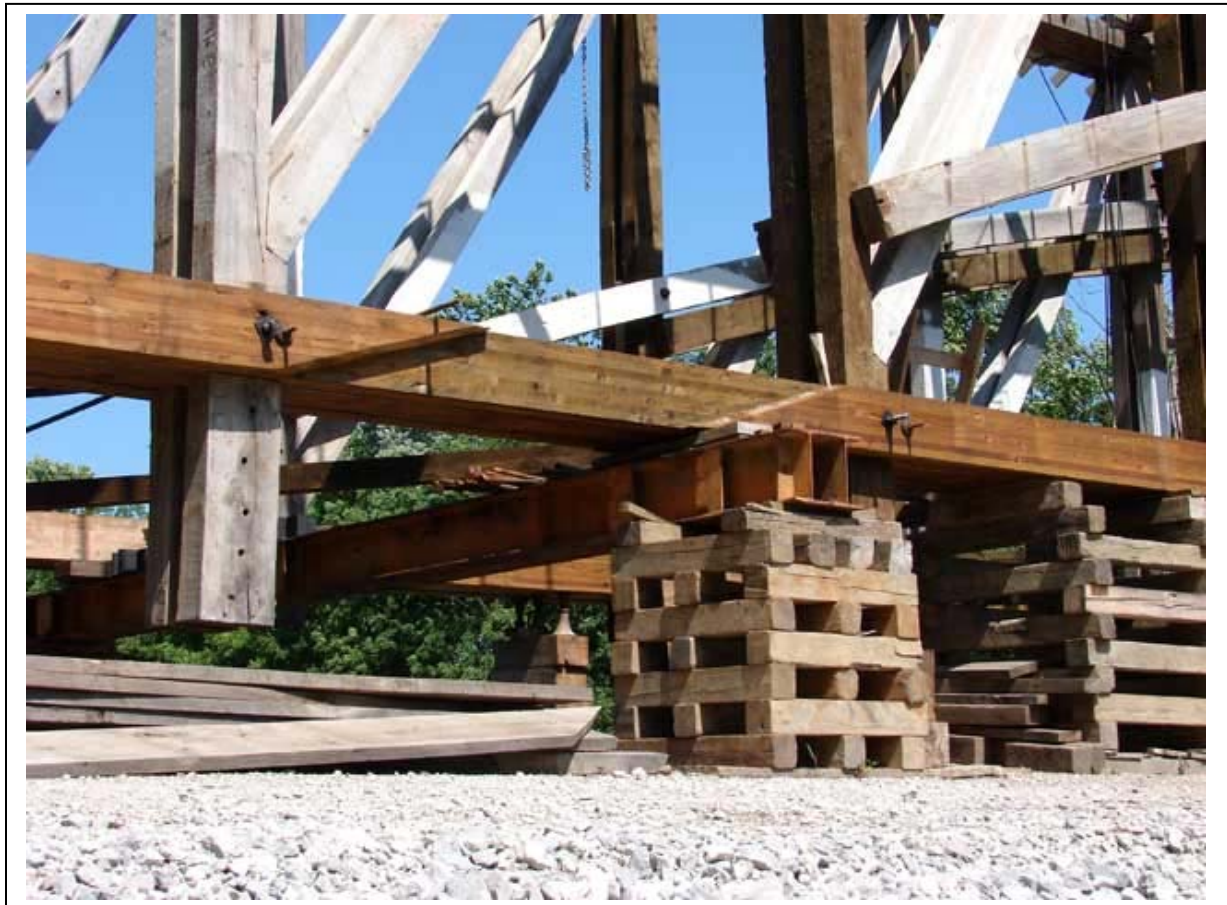
July 14th The replacing of vertical posts is ongoing, with only a few left to replace. The construction plan is to install some of the roofing and siding before the bridge is moved back over Sugar Creek. The moving crew was scheduled to arrive the week of July 16th and start preparing for the move. The move is currently scheduled for the middle of August.

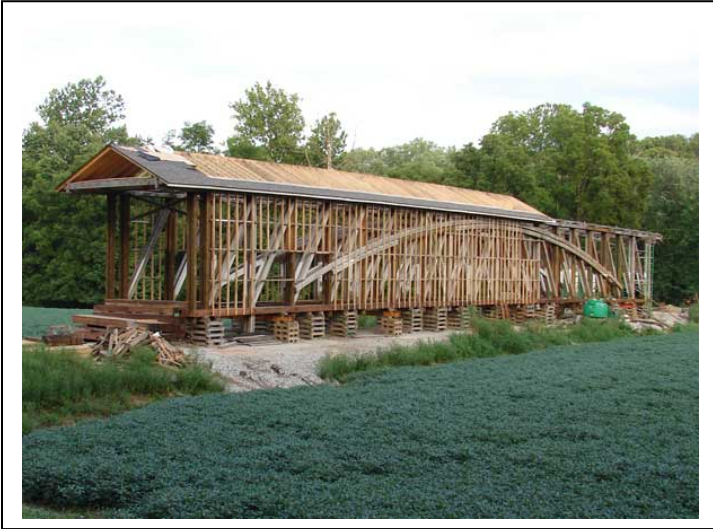
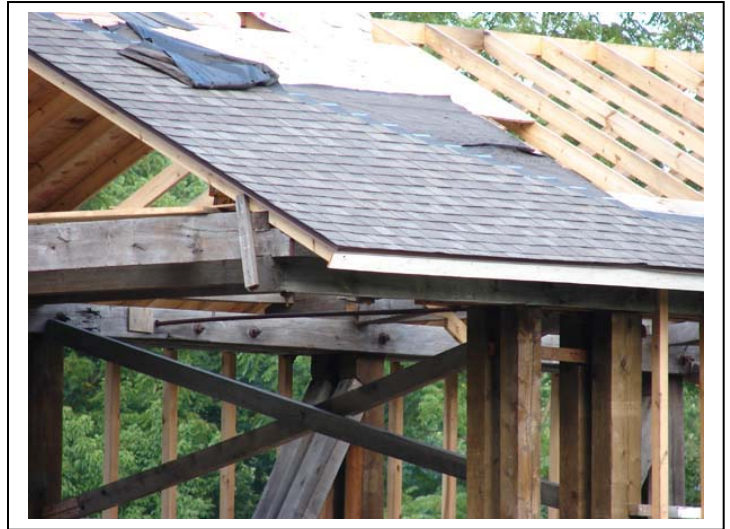
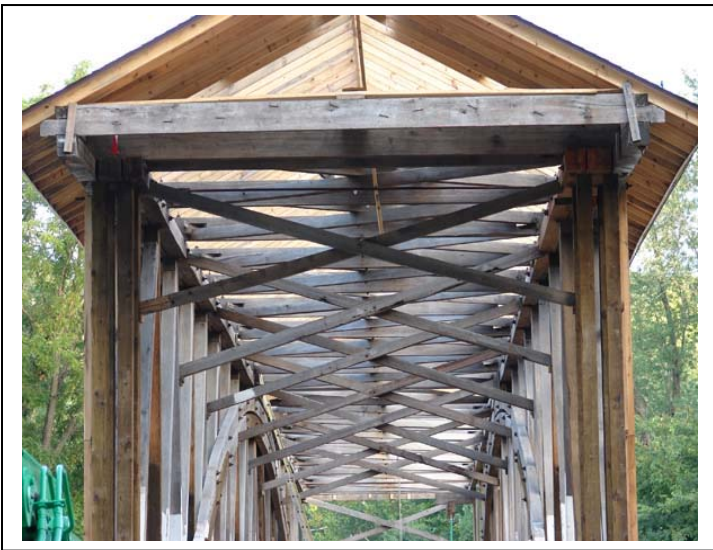
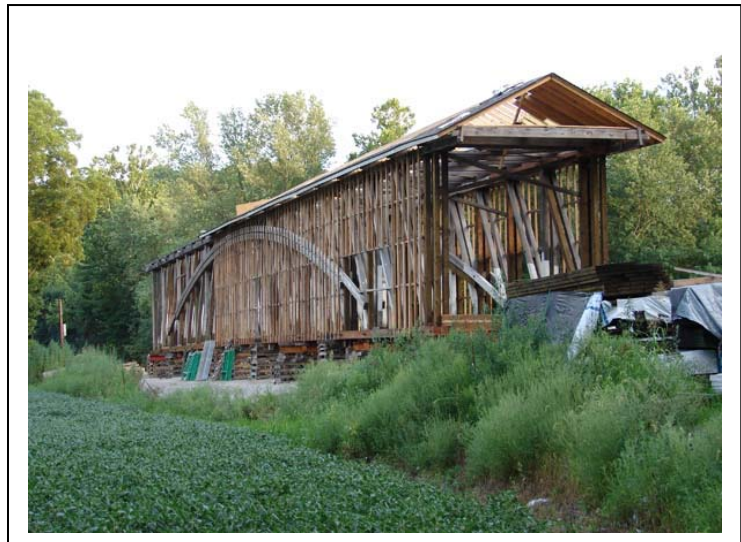
August 7. The workers are trying to get as much done as possible before the bridge is moved back over Sugar Creek. The goal is to have the rafters and the bottom rows of shingles installed while the bridge is on the road. The workers also trying to install as many siding supports as possible. Both of these jobs will go slower if the work has to be completed while the bridge is over the creek.

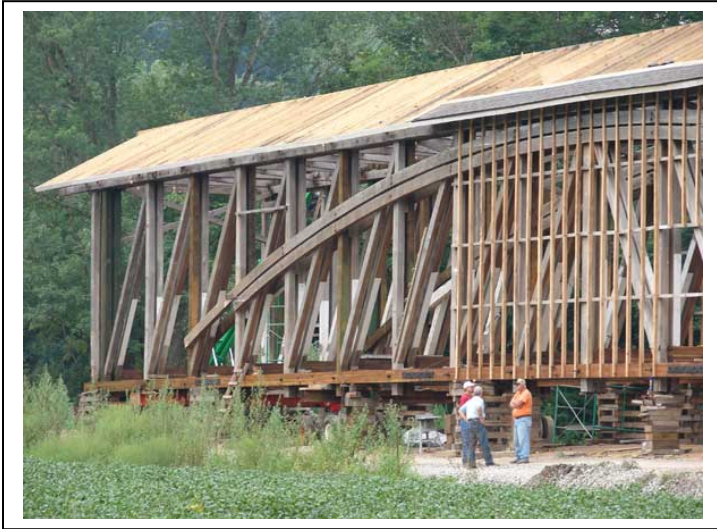
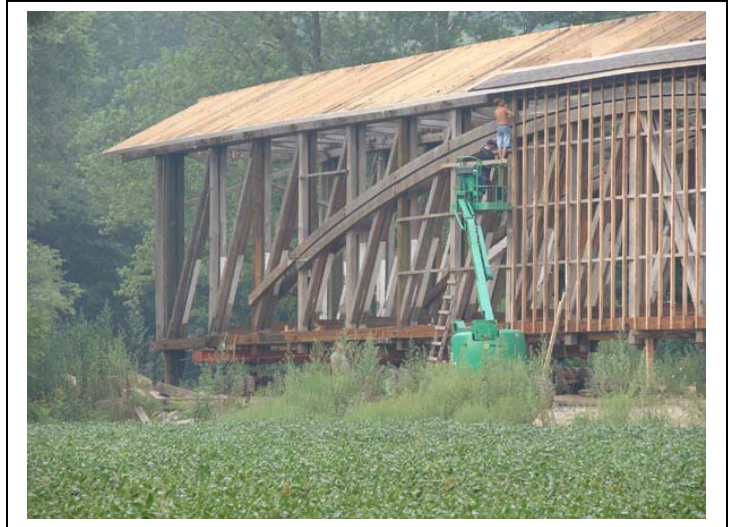
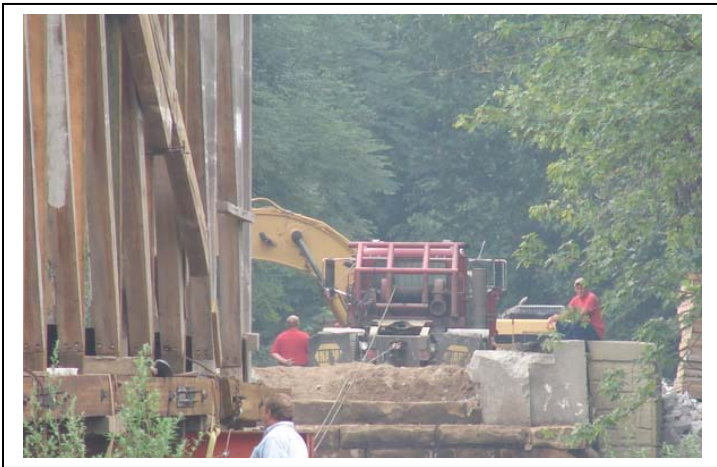
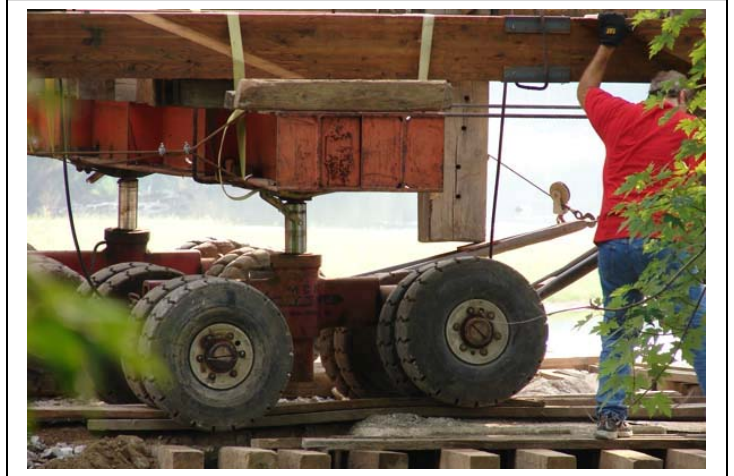
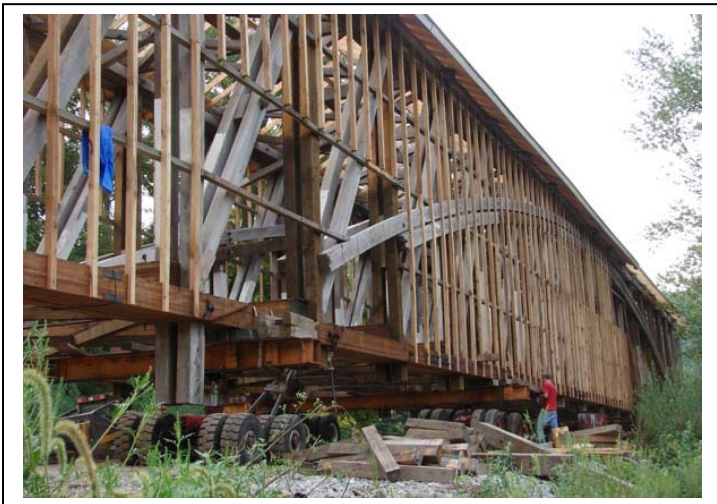
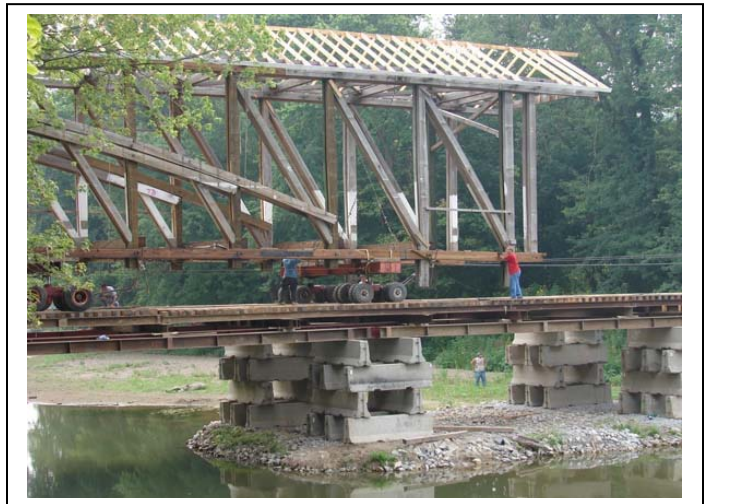
The decision was made to move the bridge on August 16th. The day the final dollies were installed and the bridge was moved closer to the creek. A winch truck (red truck in background) was placed on the south side of the Sugar Creek. Cables from the winch were connected to the dollies supporting the bridge.

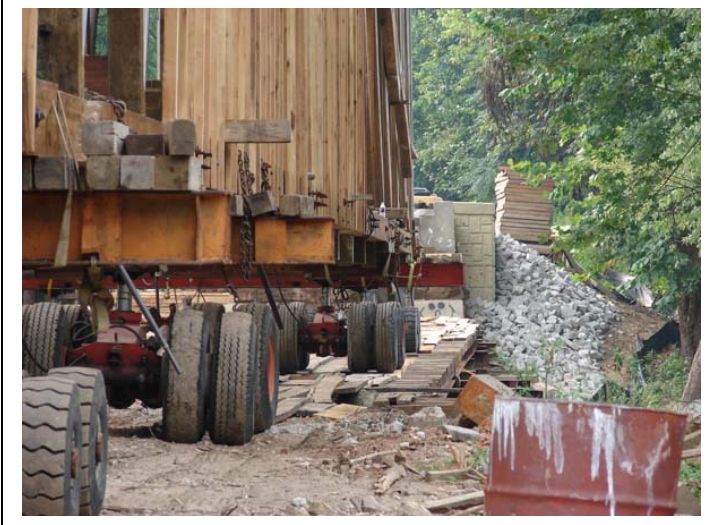
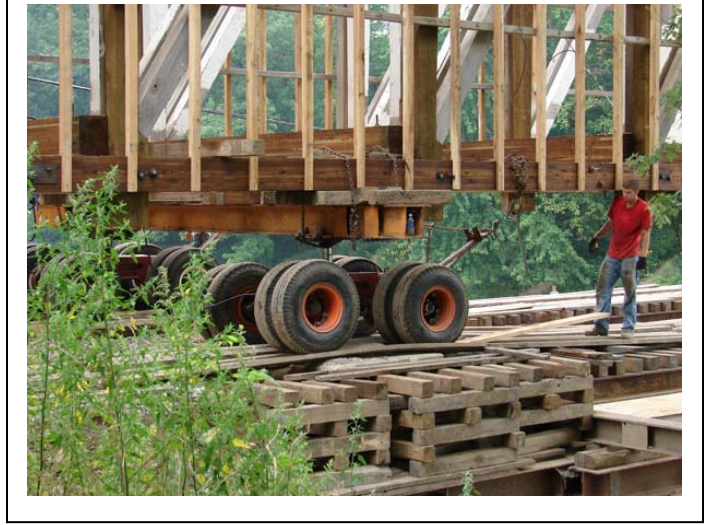
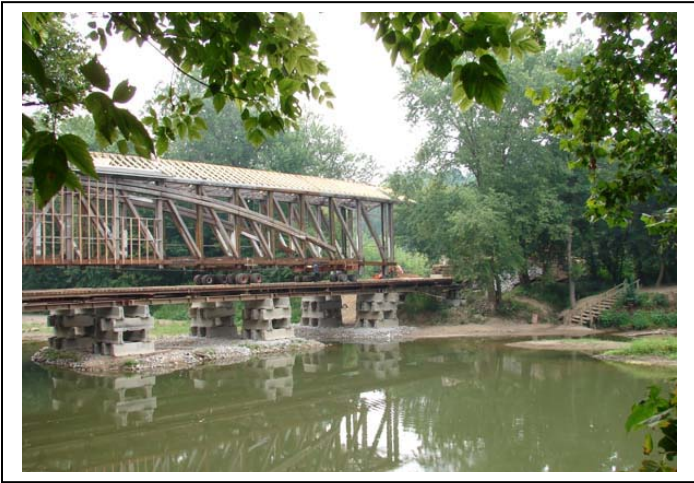
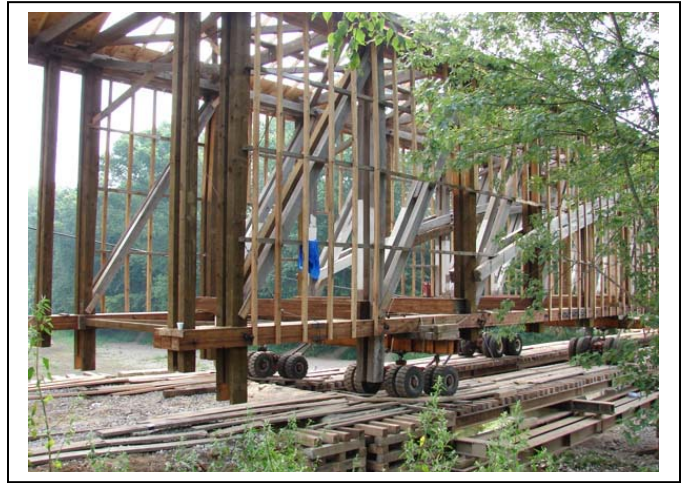
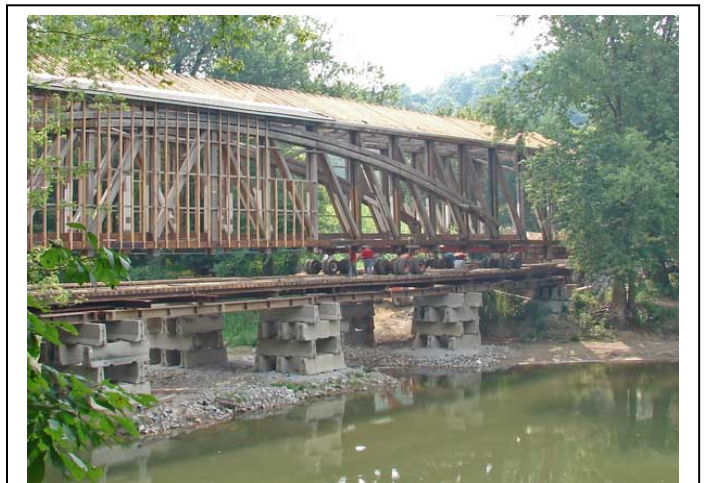
The Jackson Covered Bridge is back in its home among the trees.

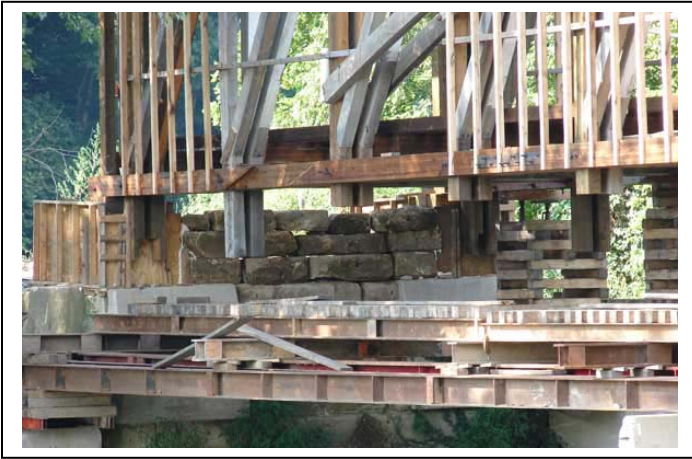
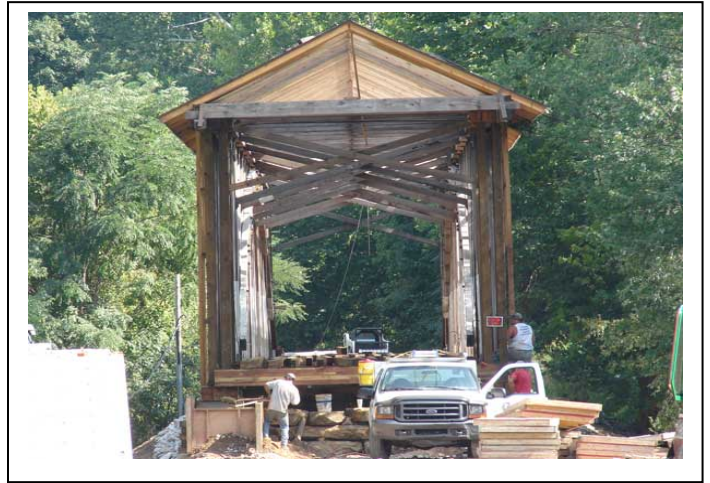
August 22nd The Jackson Covered Bridge is sitting on the temporary bridge over Sugar Creek. The workers are working on the south approach.

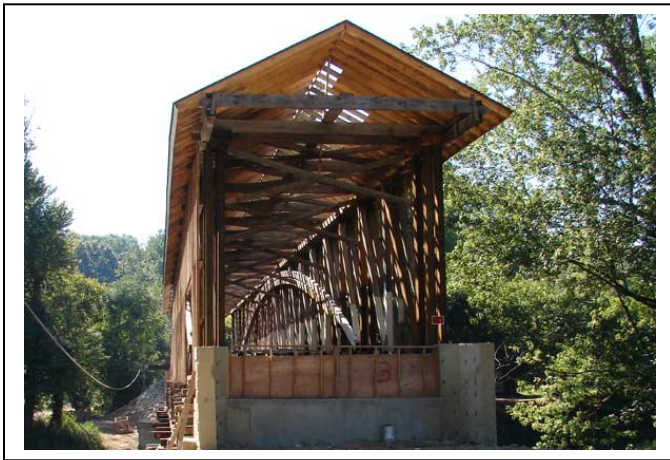
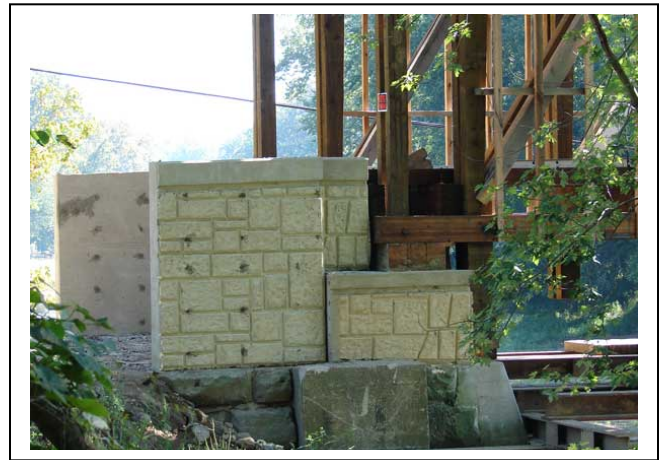
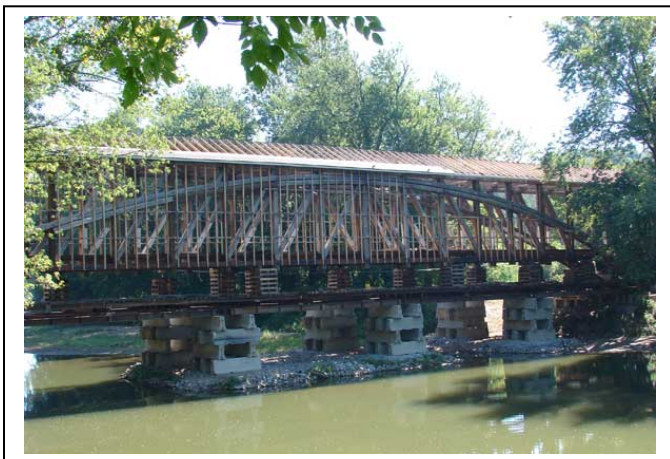
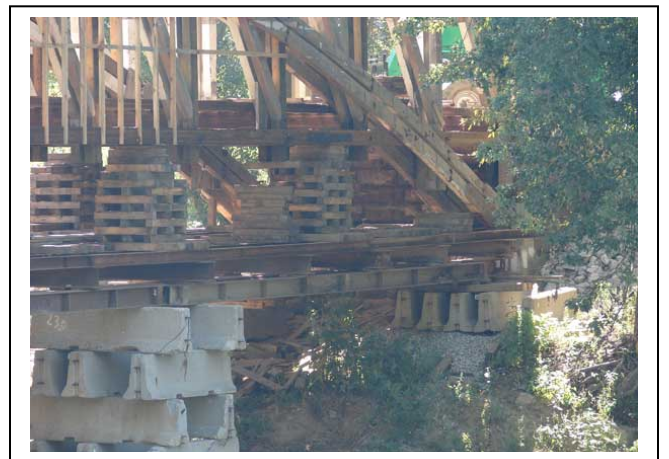
September 3rd The work continues on the north abutments. Forms have been set and concrete has been poured

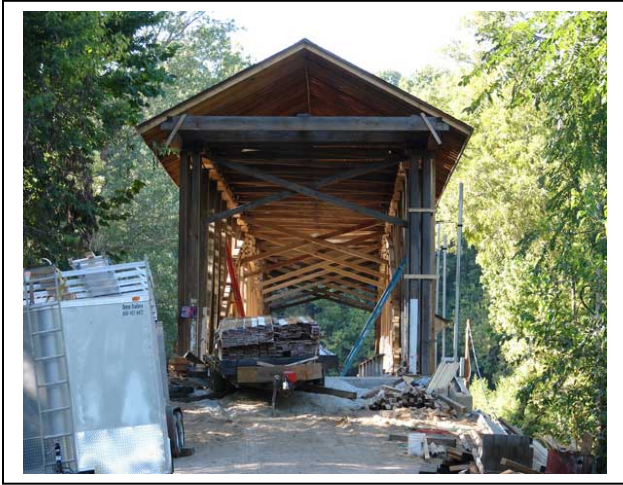
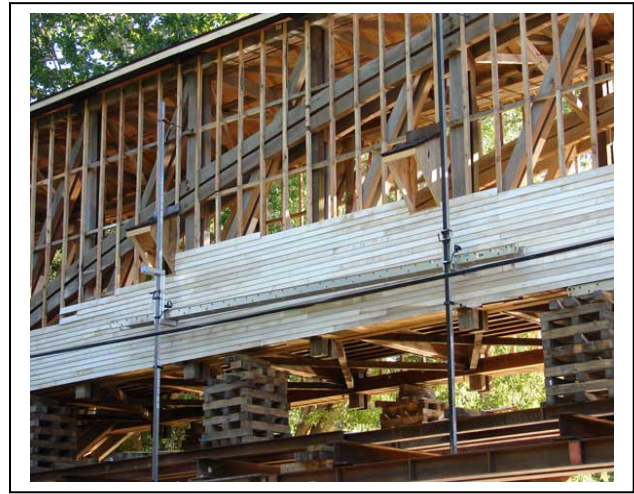
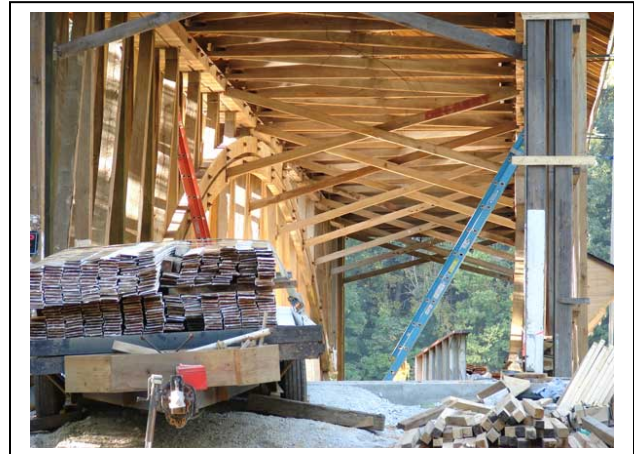
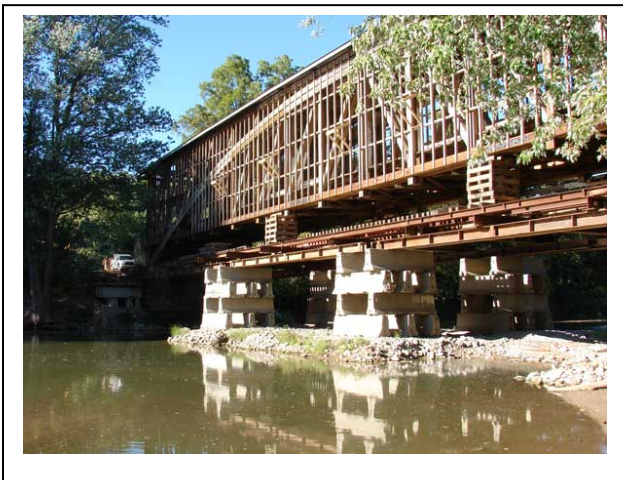
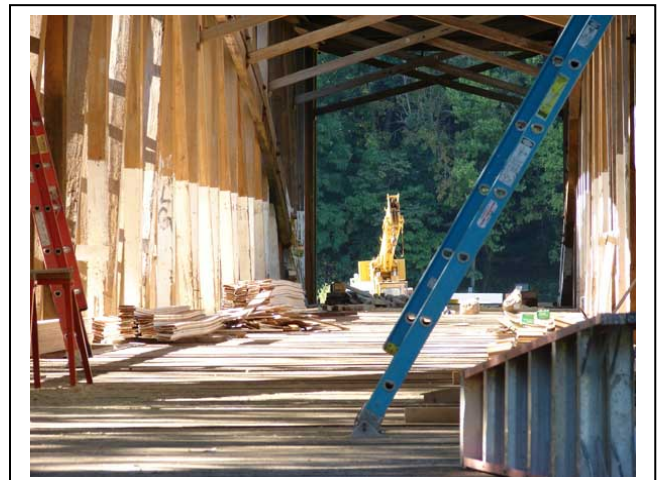
September 13th. Multiple crews are now working on the Jackson Covered Bridge, trying to get it opened before the Parke County Covered Bridge Festival. The roof crew has completed the new roof. The siding crew has started siding the east side. Major work is still being done on the north abutment.
