Jackson Covered Bridge Rehabilitation

The Jackson Covered Bridge over Sugar Creek is being rehabilitated. Work on the \$1.4 million Federal Aid project is nearly complete. The project included the removal of the roof and siding. The bridge frame was moved off of the abutments for the rehabilitation. The bridge was removed from the abutments in February 2007. The bridge was put back on the abutments in August 2007. Additional information can be found at the following website:

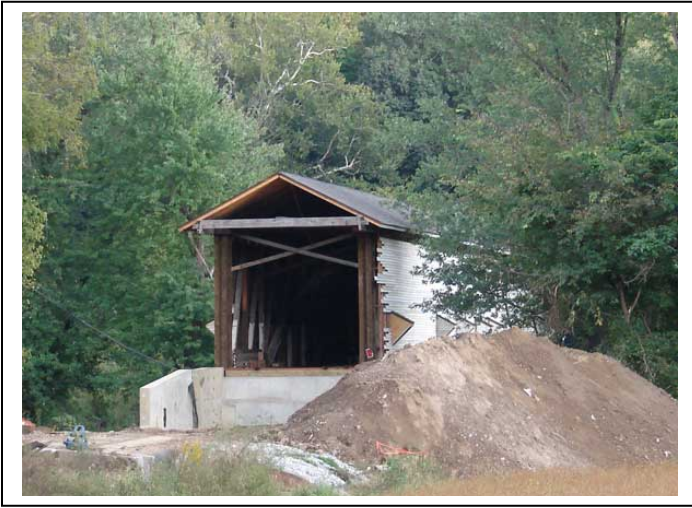
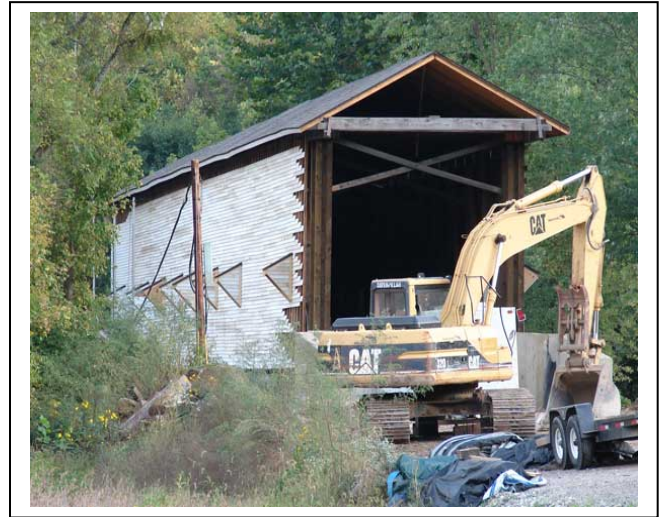
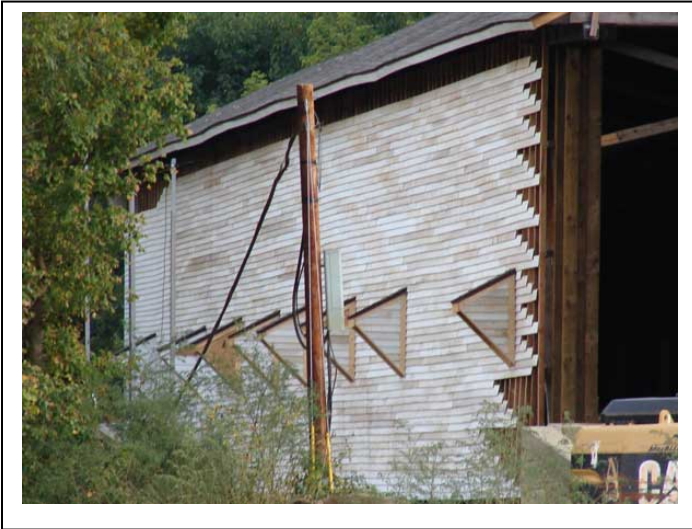
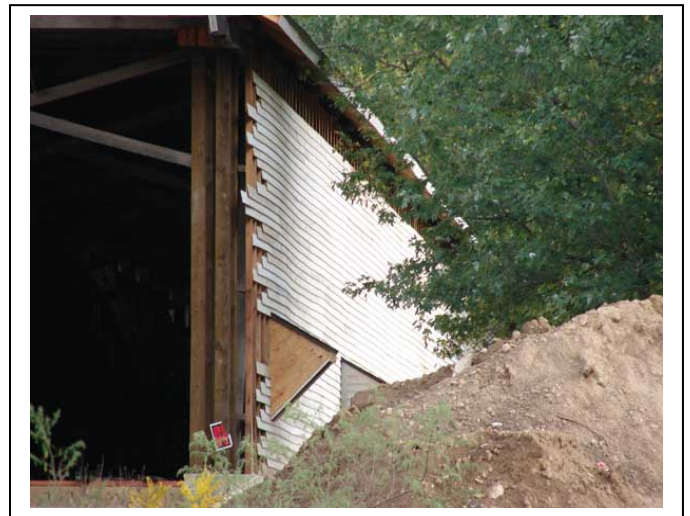
September 27th The Jackson Bridge is starting to look like the old Jackson Bridge. Most of the siding has been installed. The window openings have also been installed. The north abutment still has significant work remaining. The dog house of the bridge also needs to be constructed.

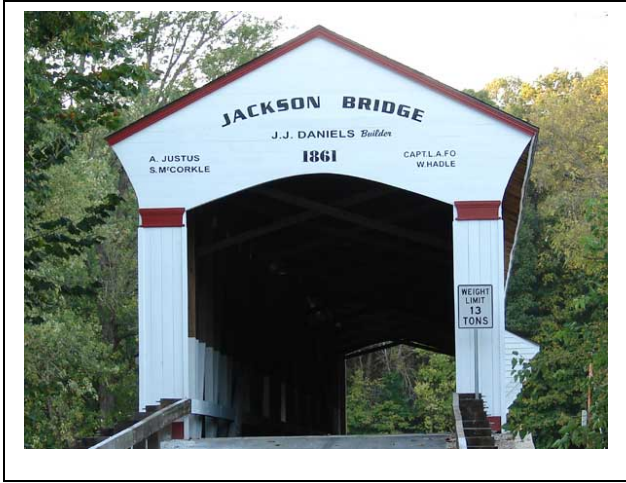
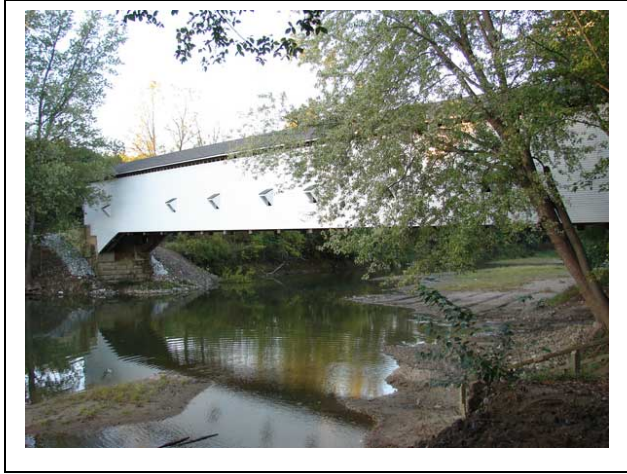
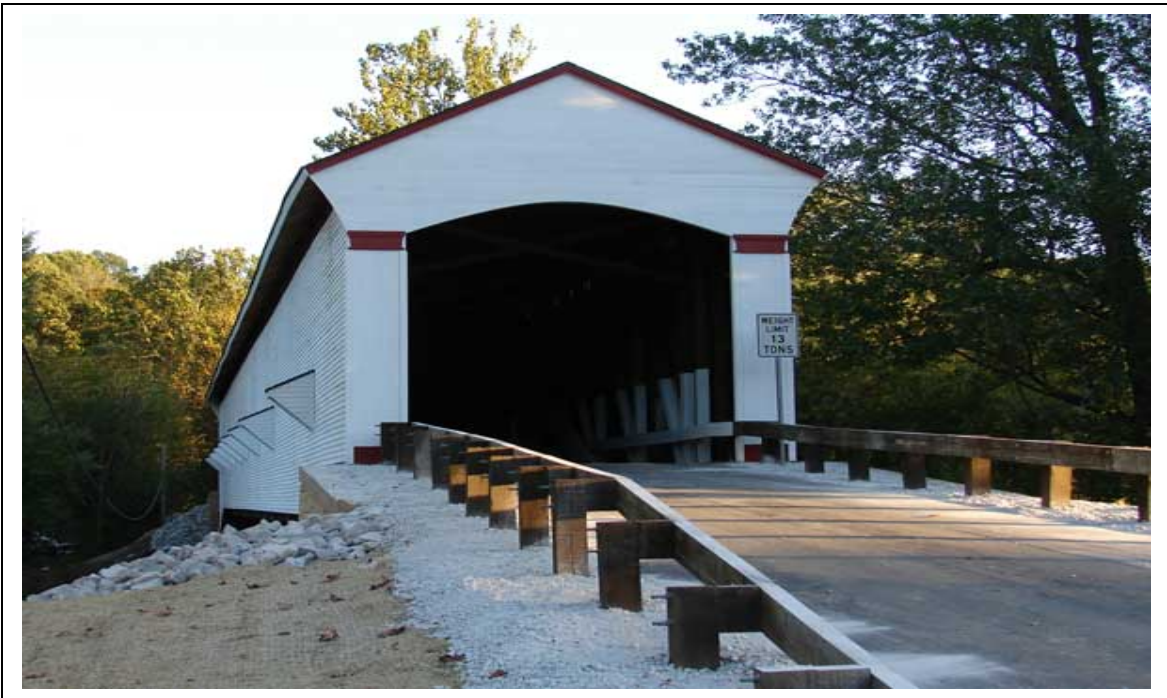
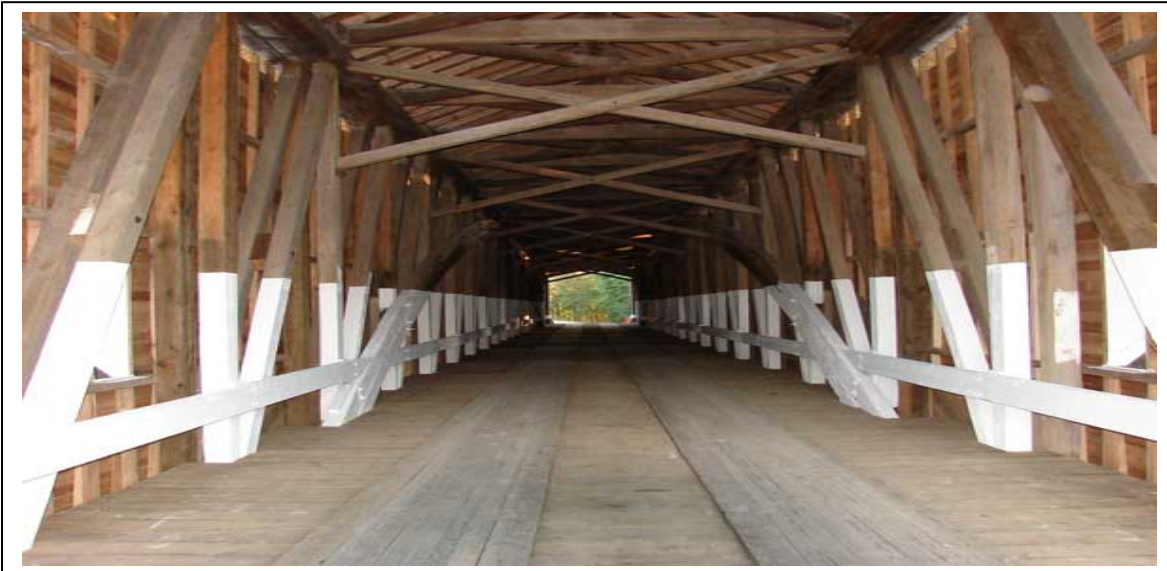
October 2007

On October 9th the Jackson Covered Bridge was opened to traffic. The bridge made the goal of being opened before the start of the Parke County Covered Bridge Festival. Some small tasks still remain (such as lettering the north end of the bridge). The bridge looks great and was quiet as cars were driving across the bridge.
